The Behaviour and Influence of Desiccation Cracking on a Full-Scale, Vegetated Infrastructure Embankment

R.A. Stirling, S. Glendinning, C.T. Davie
School of Engineering, Newcastle University, UK

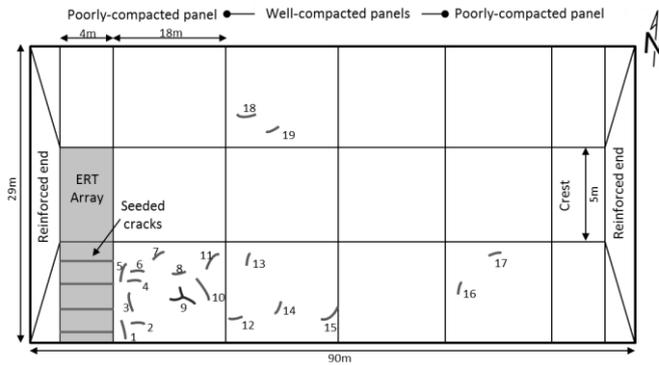
The BIONICS full-scale research embankment is a 6 m high, 90 m long embankment orientated in an east-west direction with a 1 in 2 slope that is representative of typical UK infrastructure (Figure 1). The embankment is located at Nafferton Farm,

Figure 1. Embankment schematic depicting desiccation crack distribution.

Figure 3 shows a crack seen on the embankment (Crack 4 – Figure 1). Linear cracks with limited branching are almost exclusively seen in this context and indicates the significant influence of vegetation presence, likely a result of root mass reinforcement.

To understand the behaviour of desiccation cracks at full-scale on vegetated infrastructure slopes, linear transducers were installed across an active crack site (Figure 4). The site selected was crack 9 shown in Figure 1. This crack is positioned towards the centre of the south facing ‘poorly’ compacted panel and as such is considered to not be influenced by any boundary effect as a result of embankment construction. Crack surveying identified this crack as being representative of typical crack activity.

A 4m wide x 6m high, south-facing slope section to the west of the embankment (Figure 1) is the site of a 3D electrical resistivity tomography (ERT) array operated by the British Geological Survey and Newcastle University. The array comprises a total of 281 electrodes at 0.7m grid spacing, arranged with a dipole-dipole configuration, which is highly-sensitive to horizontal resistivity variations. Alternating pairs of electrodes are used to impart current and to record the resulting change in potential. This is then related to resistance via Ohm's law ($V=IR$), and corrected for geometry, allowing the volumetric subsurface resistivity distribution to be imaged. Due to the sensitivity of resistivity to temperature, standard procedure is to correct images to a reference value, which in this study was taken to be the mean annual air temperature at the embankment site, 9.35°C. The basic principal of the ERT method as a tool for imaging moisture dynamics is that low water content corresponds to high resistivity values, and vice versa.

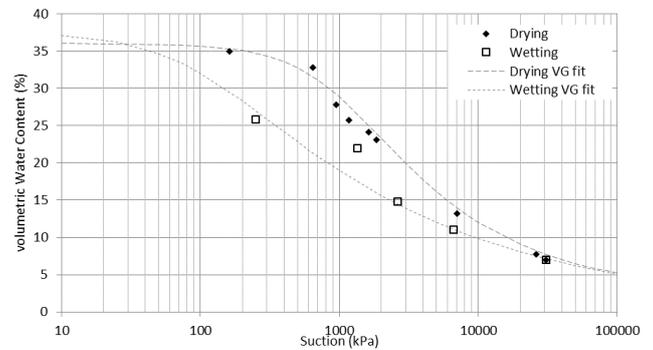
Figure 2. Soil-water retention curve (after Hen-Jones et al. 2017).

Embankment fill material was locally sourced glacial till (Durham Lower Boulder Clay). The Atterberg limits, tested in accordance with BS 1377 (1990), were 43% and 21% for Liquid and Plastic Limits respectively which classifies the material as intermediate plasticity. Compaction characterisation was conducted to BS 1377 (1990) using normal Proctor (light) compaction which found the maximum dry density to be 1.71 Mg/m^3 at a 15% optimum water content. Particle size distribution testing found the soil to be relatively well-graded in the portion $>2 \mu\text{m}$. The results of quantitative XRD analyses on the sub $2 \mu\text{m}$ fraction of the embankment fill material suggests that the clay mineral assemblages are generally similar and composed of variable amounts of illite/smectite (ranging from 42 to 54%, with a mean of 49%), chlorite/smectite (3–7% range, mean 5%), illite (16–26 % range, mean 19%) and kaolinite (23–31% range, mean 26%). Finally, the SWRC as determined by dewpoint potentiometer is presented in Figure 2.

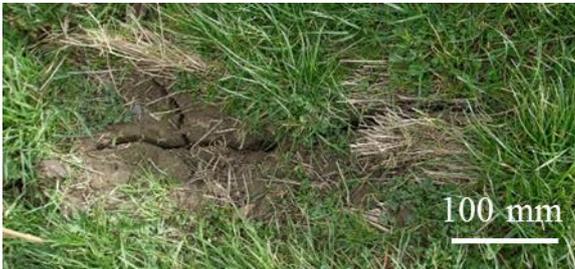
Figure 3. Typical linear cracking style on vegetated slope infrastructure in UK.

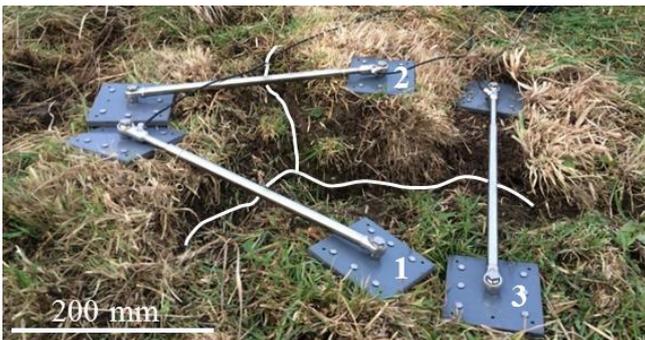
Figure 4. Transducer configuration at monitored crack site.

The three stainless steel transducers had a 200 mm stroke range and were capable of operating between -40 to $+150^{\circ}\text{C}$ using contactless (inductive coil) sensing. At the time of installation, grass cover was cut back to expose the crack, as depicted in Figure 4 by the white line. PVC plates fitted with six 80 mm spikes were used to fix each transducer end to opposing sides of the crack. Care was taken not to place the fixings too close to the crack aperture so not to disturb the crack as well as to leave sufficient travel to accommodate either direction of movement following installation.

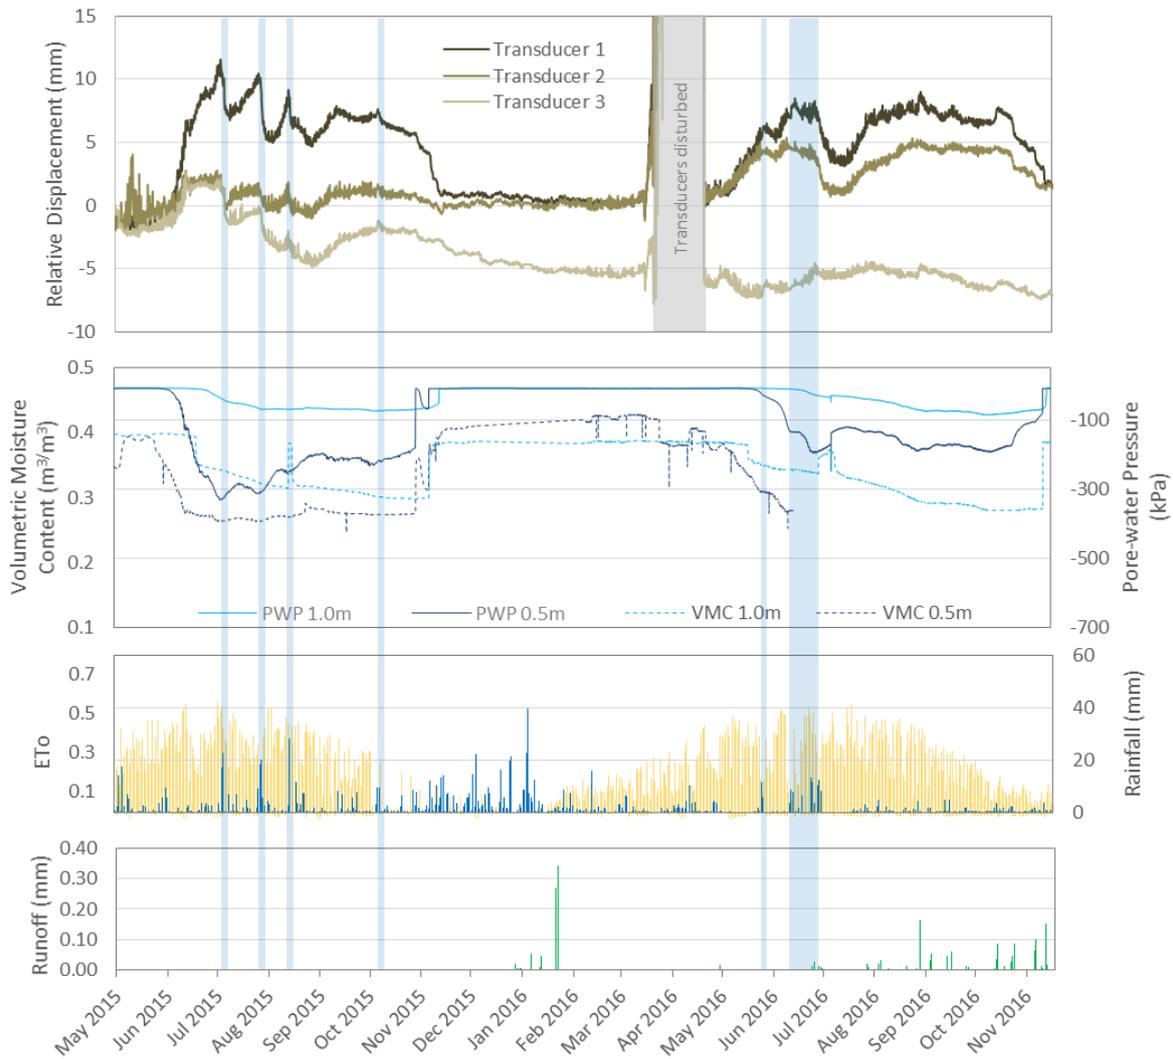
The behaviour of the crack from May 2015 to November 2016 is presented in terms of transducer displacement in Figure 5. Also presented is corresponding volumetric water content and soil matric suction data from a monitoring profile 1.6 m away from the crack site. Rainfall, potential evapotranspiration (ET_o) and runoff data is also presented for the same period. A diurnal signal in transducer displacement was detected with a maximum of 1.5 mm recorded.

Figure 5. Crack and environmental monitoring time series data.

The crack transducers indicate the onset of crack aperture opening at the start of June. This aligns well with the onset of suction generation as measured at 0.5 m depth and follows a period of limited rainfall and high ET_o. Once open, a series of rainfall events are shown to produce a response in suction and most noticeably, result in a rapid reduction in crack aperture (highlighted). Continued high levels of ET_o during this period is seen to maintain suctions between 200-320kPa, enabling the crack to re-open between the three major rainfall events.

Transducer 1 exhibits the greatest response to environmental variation. However, all three transducers capture the interaction between dominant ET_o and punctuated rainfall events throughout the summer months. Following the fourth highlighted rainfall event, total ET_o reduces and rainfall dominates. The crack aperture is shown to reduce consistently from October to mid-November 2015, with assumed closure (return to original displacement in transducers 1 and 2) simultaneously with the loss in suctions.

During the 2015-2016 winter, little to no displacement is evident on the monitored crack. Relatively high water content is sustained suggesting saturated conditions which result in previously undetectable runoff following high rainfall (January 2016).

Transducers were disturbed in mid-March through April 2016. This is attributed to burrowing activity observed across the embankment by rabbits (*Oryctolagus cuniculus*). The influence of macrobiota on the enhancement of infiltration on vegetated slopes is a little addressed aspect of ecological-geotechnical engineering.

In 2016, the crack aperture is again shown to open in May during a period of sustained high ETo and low rainfall. The rapid response of crack displacement to rainfall events is seen again, although unlike the previous year, a wet period late-June – July is experienced which limited the development of deeper suctions and results in measurable runoff.

There exists a clear connectivity between cracking behaviour, near-surface (<1 m) saturation and runoff. Taking the period May-May, despite relatively high rainfall events during the active crack season, no runoff is measured.

Conversely, once the crack is assumed to have closed (post- mid-November 2015), runoff is produced from similar magnitude rainfall events. Although the occurrence of runoff is linked to soil surface saturation, it is also considered that reduced runoff is linked to the presence of open cracks on the slope surface and that these result in the interception of this flow. Therefore, the infiltration potential of

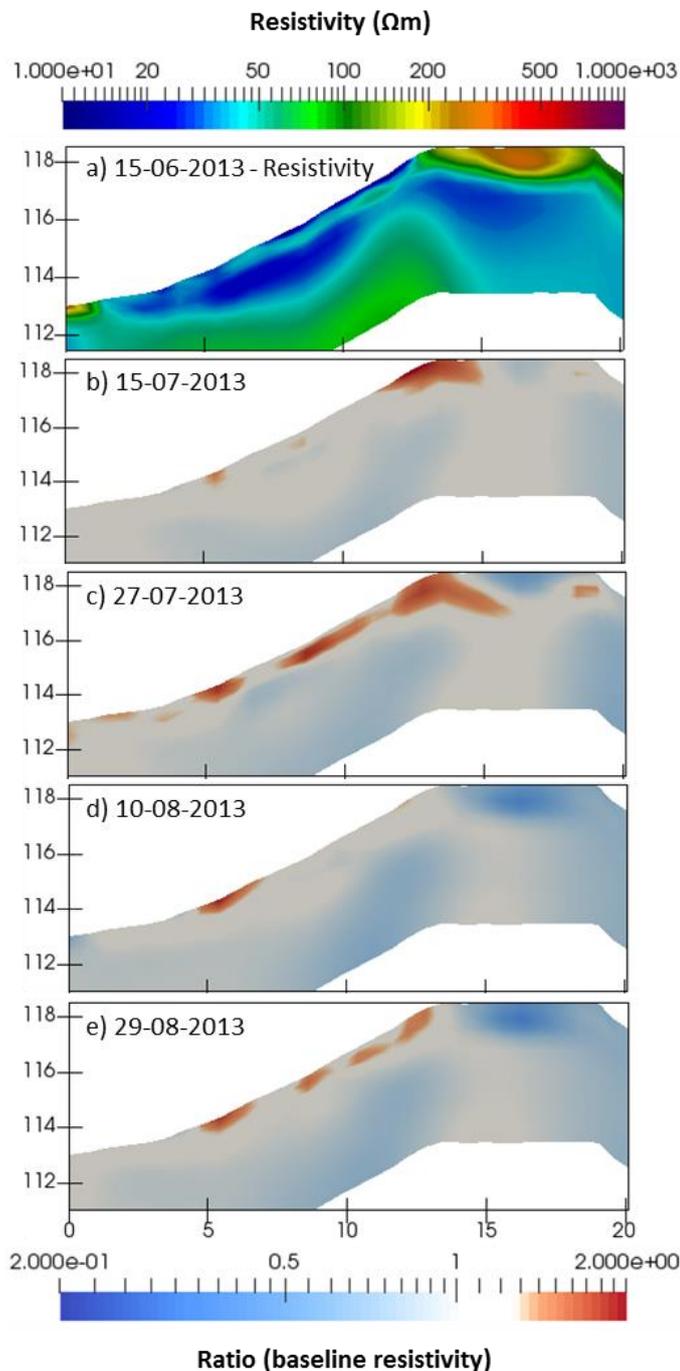
The ERT array took measurements on an approximately daily basis. The images presented here show “slices”, extracted along the central line of the array from 3D volumetric images during a period of rapid drying over the course of summer 2013. Figure 6a shows the initial resistivity distribution recorded on 15th June, and highlights the highly permeable crest ballast (approx. 150-250 Ωm), the near-saturated embankment core (approx. 20-50 Ωm) and a stratified slope flank. The following images present the ratio change in resistivity with respect to the first date - the associated colour scale has been chosen to highlight features characterised by a resistivity increase greater than 30 % (orange to red).

Figure 6. Developing crack features as imaged using electrical resistivity.

The development of crack features on the Southern flank of the BIONICS embankment may be imaged, which tallies with observations made during field surveys over the same period. The development of these crack features may be described as follows: in Figure 6b (15th July 2013), taken one month after the initial resistivity distribution image, significant drying has occurred at the south-facing portion of the crest ballast, extending into the fill material, this is attributed to the embankment orientation. The south-facing aspect of the ERT monitored section is exposed to both the prevailing wind direction (South-westerly) and the longest daily sunshine making this region experience the greatest degree of evapotranspiration. The influence of slope exposure is further demonstrated by the prevalence of cracking to the south-west end of the embankment (Figure 1).

Further down the slope flank, localised increases in resistivity are observed at 5.5 and 8m, corresponding to the locations of known cracks from previous field surveys; walkover surveys confirmed the presence of these cracks during the summer 2013 period.

By 27th July (Figure 6c), the two crack features have increased in volume, and much of the upper 1m of the slope flank is characterised by significant resistivity increases; observations during this time described significant extensive drying of the topsoil. Following heavy rainfall over the subsequent two weeks, the embankment surface wets up rapidly, and on 10th August (Figure 6d), only the bottom anomaly is visible, as the other features heal due to swelling associated with infiltration of rainwater into the clay fill. Drying of the near-surface then resumes: on 29th August, (Figure 6e), the anomalies have increased in volume, clearly illustrating four distinct crack locations where soil resistivity has increased by more than 30 % with respect to the baseline date at the start of the summer drying period. As well as being noted during summer 2013 field surveys, these four cracks are reoccurring features captured in multiple annual field surveys. In Figure 7, the resistivity distribution for the same embankment segment is shown during the winter of the following year (December 2014; scale same as in Figure 6).

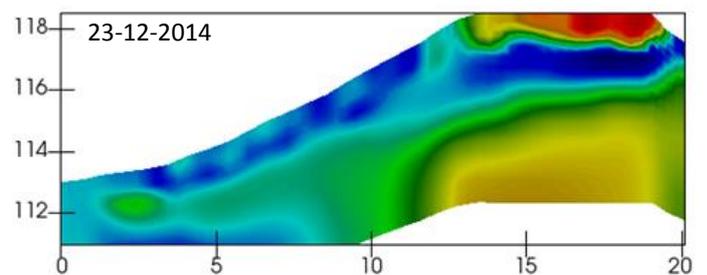
Figure 7. Low resistivity values associated with elevated water contents beneath crack locations.

Blue contours highlight low resistivity values in the vicinity of the existing crack locations. These values are associated with elevated water content

“plumes” arising from infiltration of rainwater via the cracks, and demonstrate the capacity of ERT imaging to capture the soil response to both rapid drying and wetting, in terms of crack development and evolution.
